## **STUDY OF WINDOW FACADES AT THE V.A. MEDICAL CENTER - WACO TEXAS**

by: John H. Myers  
Center for Architectural Conservation  
Georgia Institute of Technology

The substantial rehabilitation of buildings at the VA Medical Center in Waco, Texas, includes treatment of the original windows. In order to make decisions on the type and level of repair and/or replacement required, a study of several areas is required. These areas include 1) historical significance of the complex and windows 2) functional requirements for the windows 3) a review of comparable projects 4) identification and ranking of options meeting the requirements and 5) a comparison of the options.

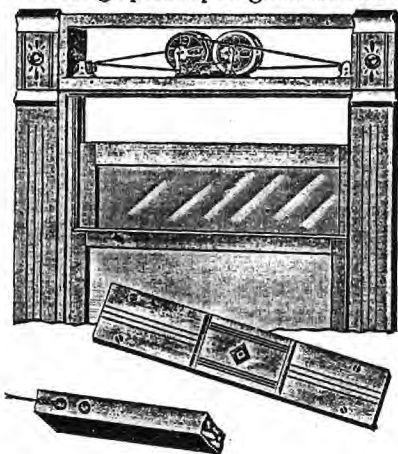
*the security balance claimed a capacity of 4 to 100 pounds (1896)*

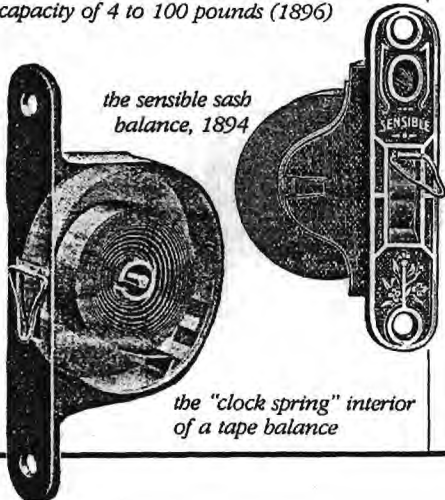
*the sensible sash balance, 1894*

*the "clock spring" interior of a tape balance*

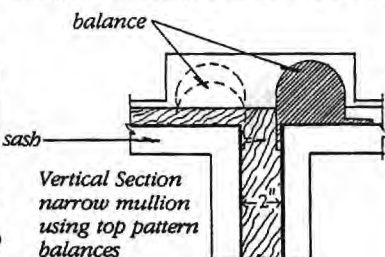
*Vertical Section narrow mullion using top pattern balances*

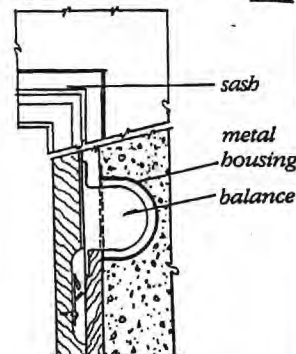
*Vertical Section showing metal housing for sash balances used with concrete construction*
